Asbestos and Lead Screen Report

Burien Community Center Annex

425 SW 144th St

Terracon Project No. 81207008

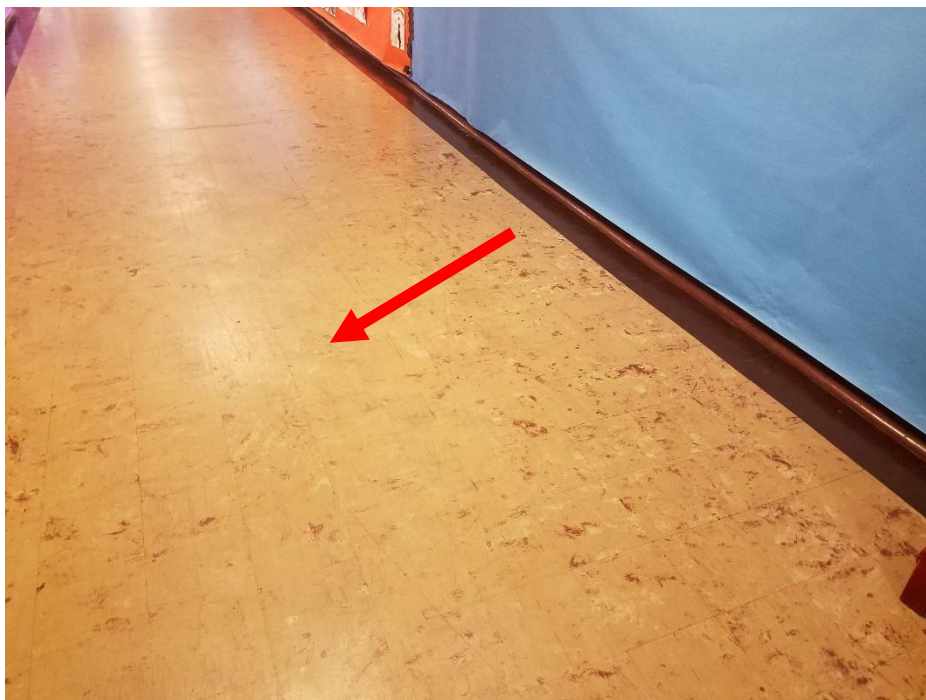
SAMPLE NO.	DESCRIPTION	MATERIAL LOCATION	PERCENT/ TYPE ASBESTOS	FRIABILITY	CONDITION	EST QUANTITY
BCC-1-01 BCC-1-02	9"x9" Tan vinyl floor tile w/ red streaks with black mastic	Hallways and classrooms in northern building.	Tile: 5-6% Chrysotile Mastic: ND-3% Chrysotile	Non-Friable to Friable	Poor-Good	7,000 SF
BCC-3-01 BCC-3-02	1'x2' Brown vinyl floor tile with black mastic	Cut to size at base of walls throughout northern building.	Tile: 4-5% Chrysotile Mastic: 2% Chrysotile	Non-Friable	Good	4000 LF
BCC-11-01	12"x12" Tan over red layered vinyl floor tile w/ black mastic	Beneath office carpeting in places in northern building.	Tile: 3-6% Chrysotile Mastic: ND	Non-Friable	Good	300 SF*
BCC-12-01	12"x12" Tan over tan layered vinyl floor tile w/ black mastic	In places in the northwest hallway of the northern building.	Tile: ND Chrysotile Mastic: 4% Chrysotile	Non-Friable	Good	100 SF*
BCC-13-01	12"x12" Tan vinyl floor tile w/ black mastic and compact brown material	In places in the northwest hallway of the northern building.	Tile: ND Mastic: 4% Chrysotile Brown Material: 6% Chrysotile	Non-Friable	Good	100 SF*

HSA No. 1. 9"x9" Tan vinyl floor tile w/ red streaks with black mastic

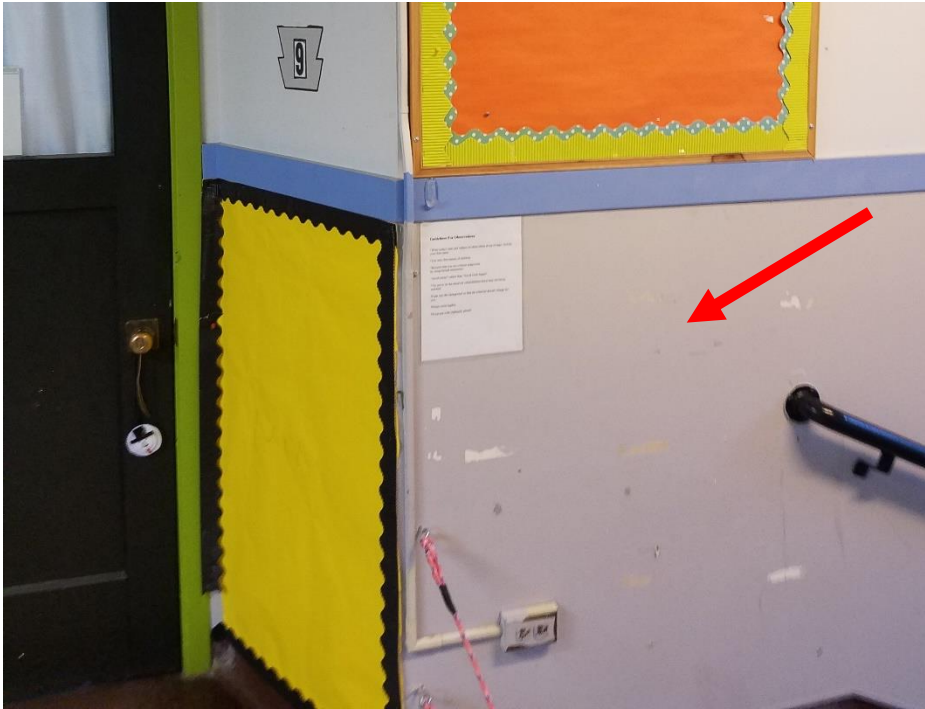
HSA No. 2. White gypsum wall board w/ joint compound

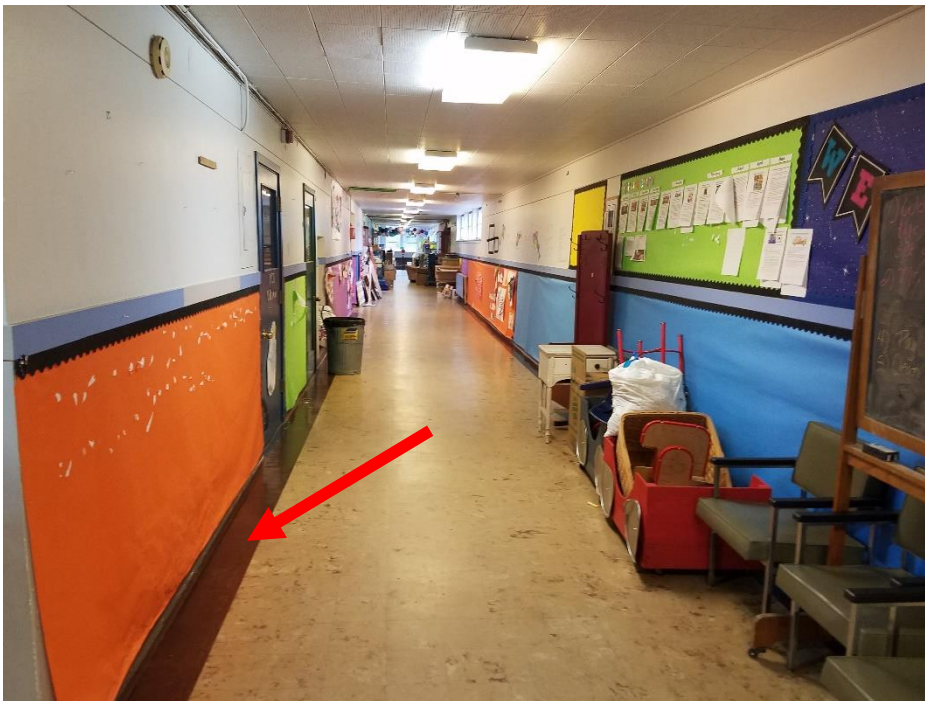
HSA No. 3. 1'x2' Brown vinyl floor tile with black mastic

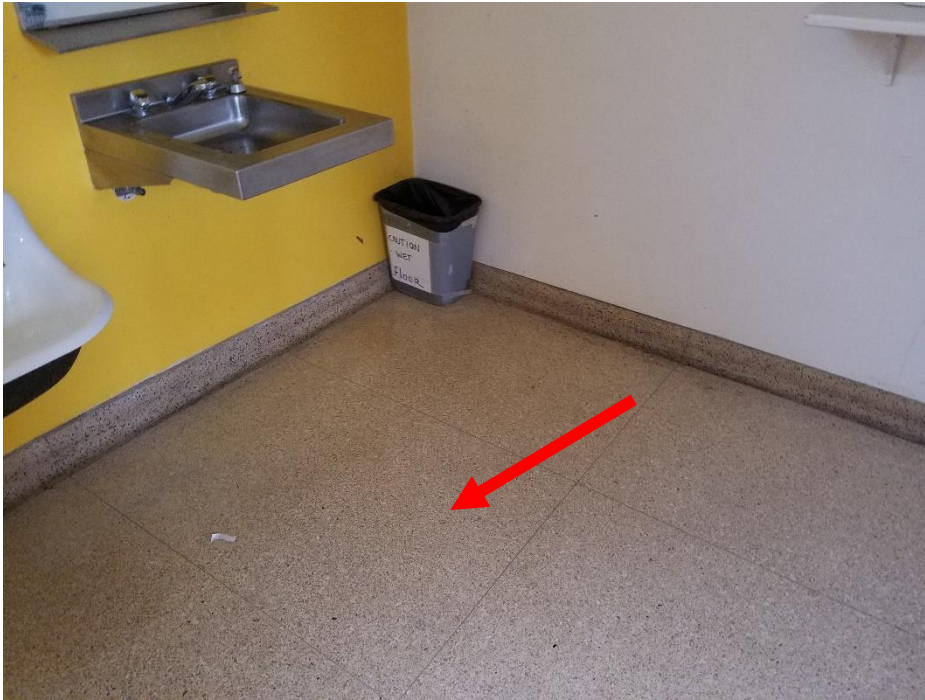
HSA No. 4. 2'x3' Tan ceramic floor tile w/ light specks and brown mastic

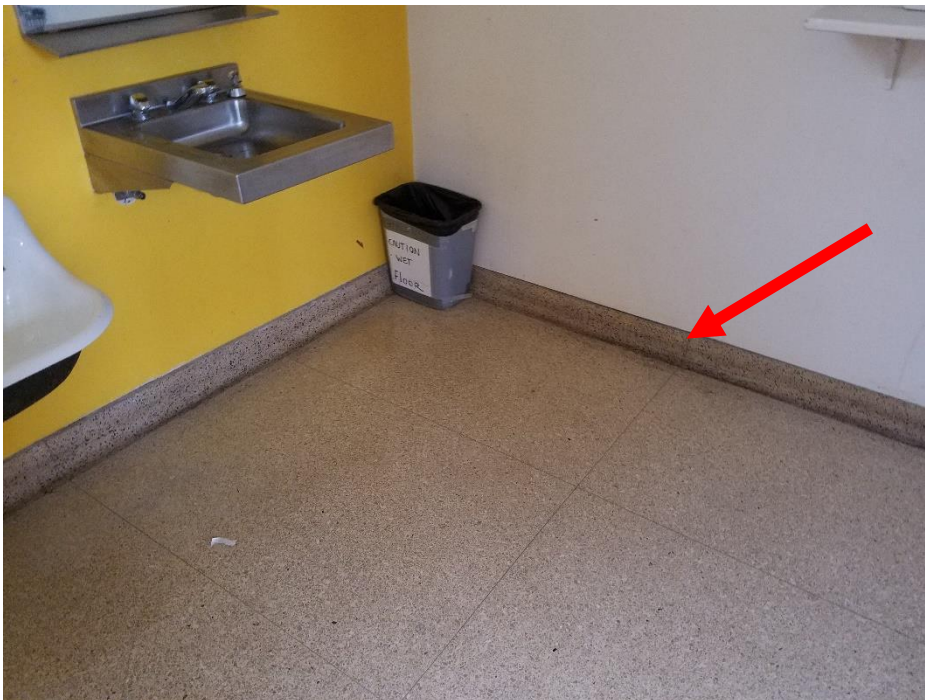
HSA No. 5. Tan ceramic floor tile w/ dark specks and yellow mastic (used as cove base)

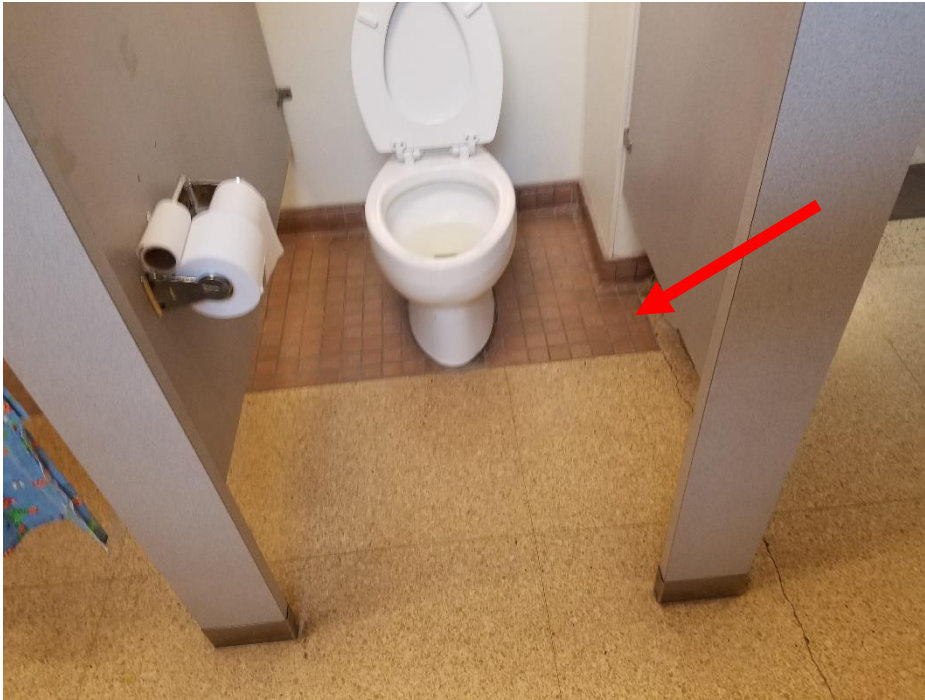
HSA No. 6. 2"x2" Red ceramic floor tile w/ grey grout

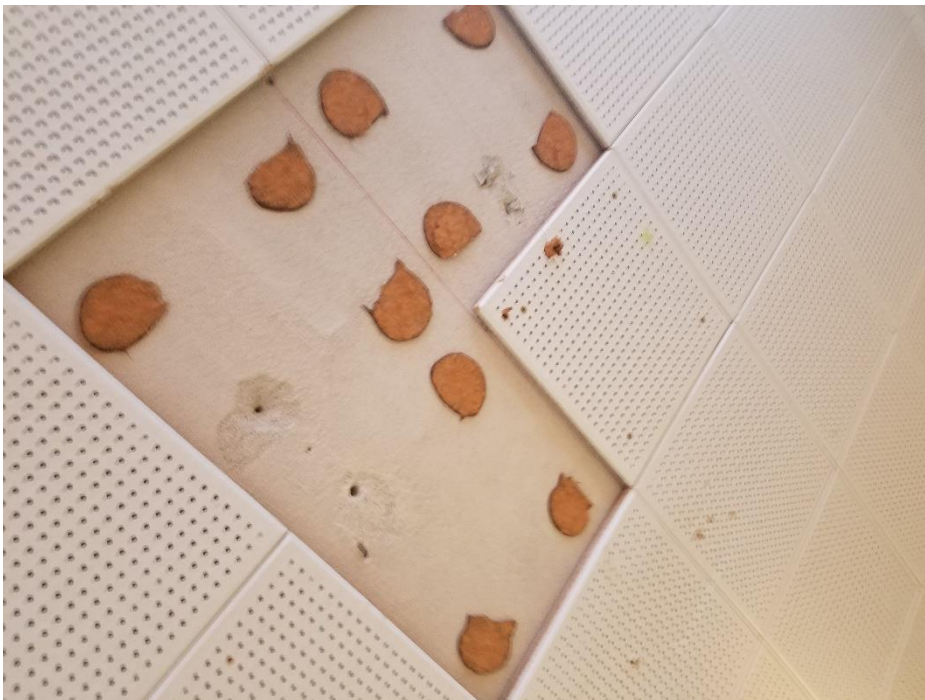
HSA No. 7. 12"x12" White porous ceiling tile w/ brown mastic

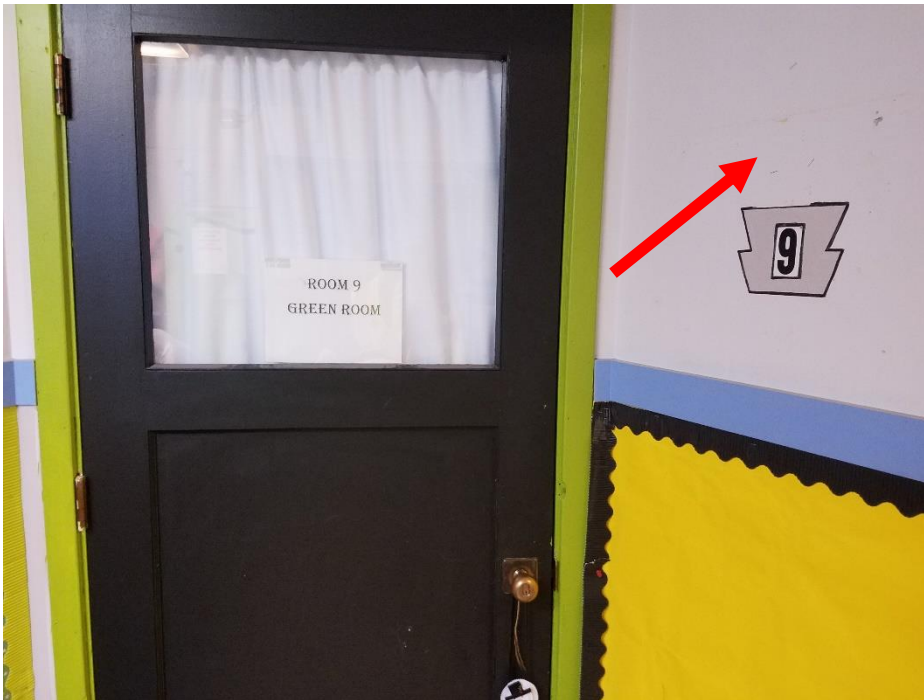
HSA No. 8. Plaster

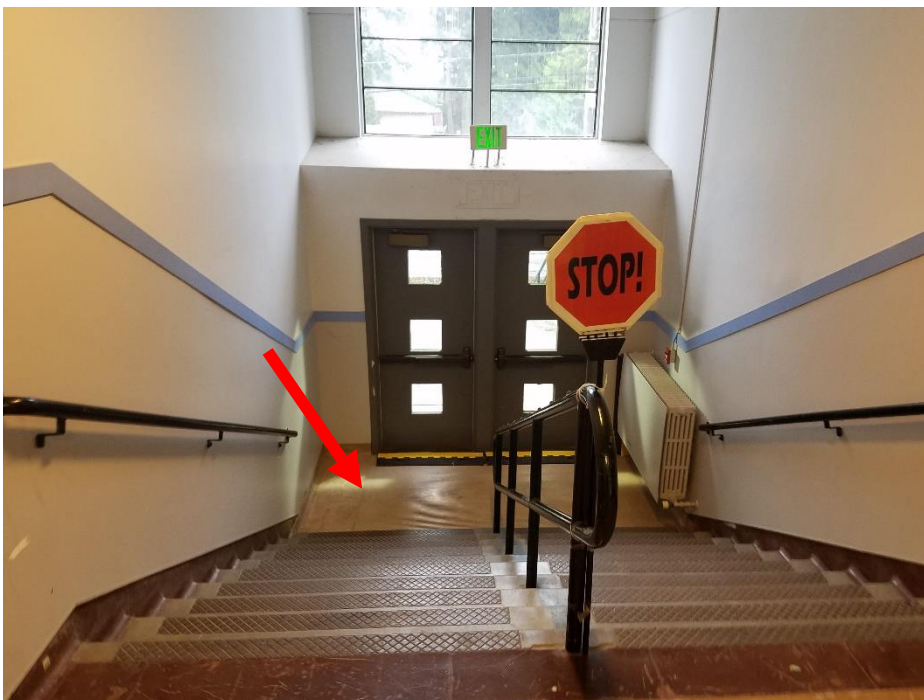
HSA No. 9. Tan vinyl floor sheet w/ yellow mastic

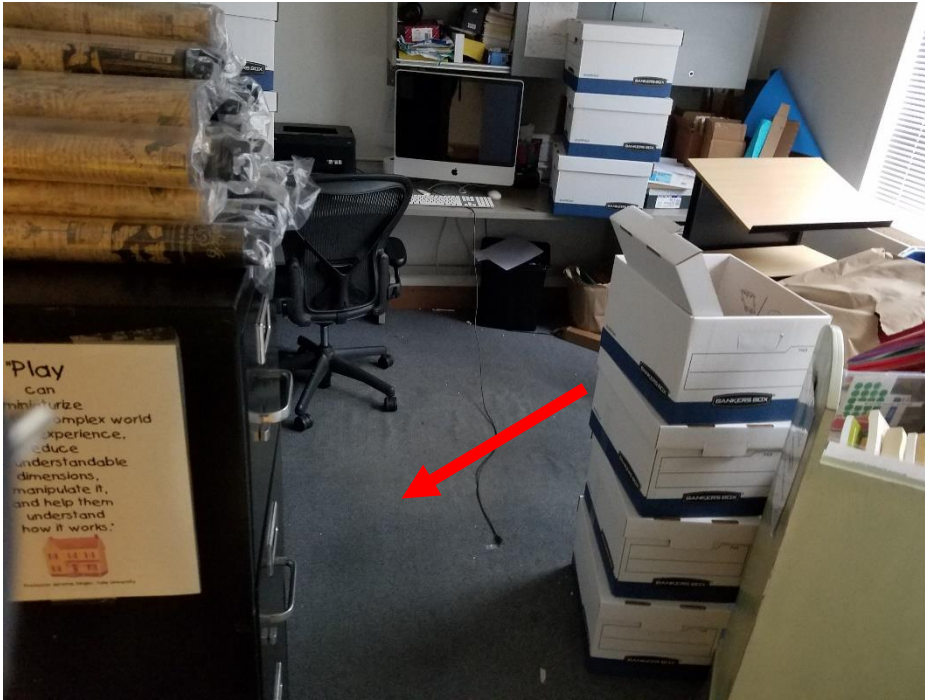
HSA No. 10. Blue carpet w/ yellow mastic

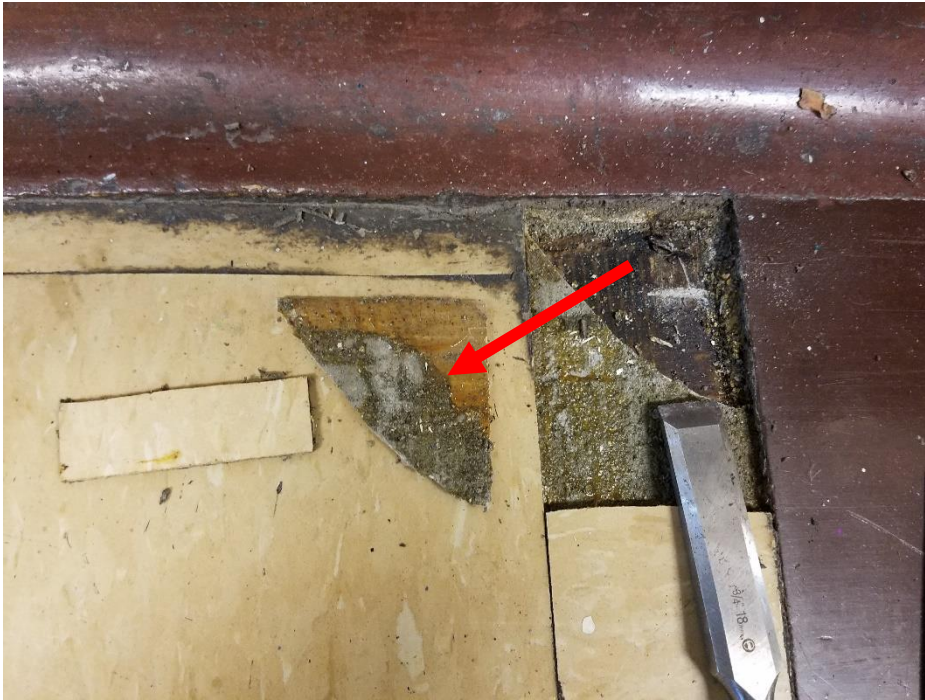
HSA No. 12. 12"x12" Tan over tan layered vinyl floor tile w/ black mastic

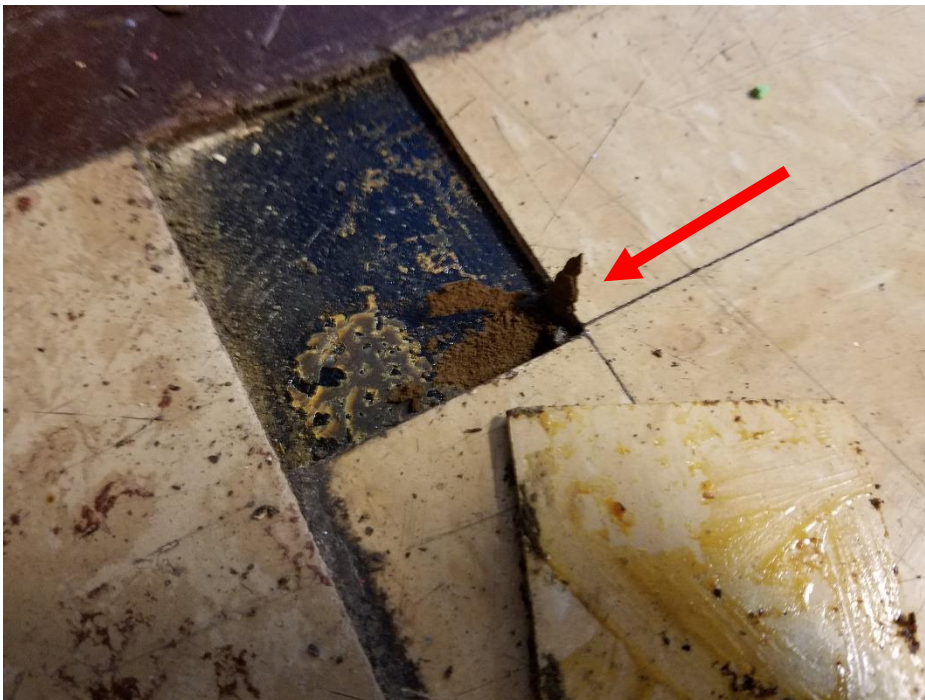
HSA No. 13. 12"x12" Tan vinyl floor tile w/ black mastic and compact brown material

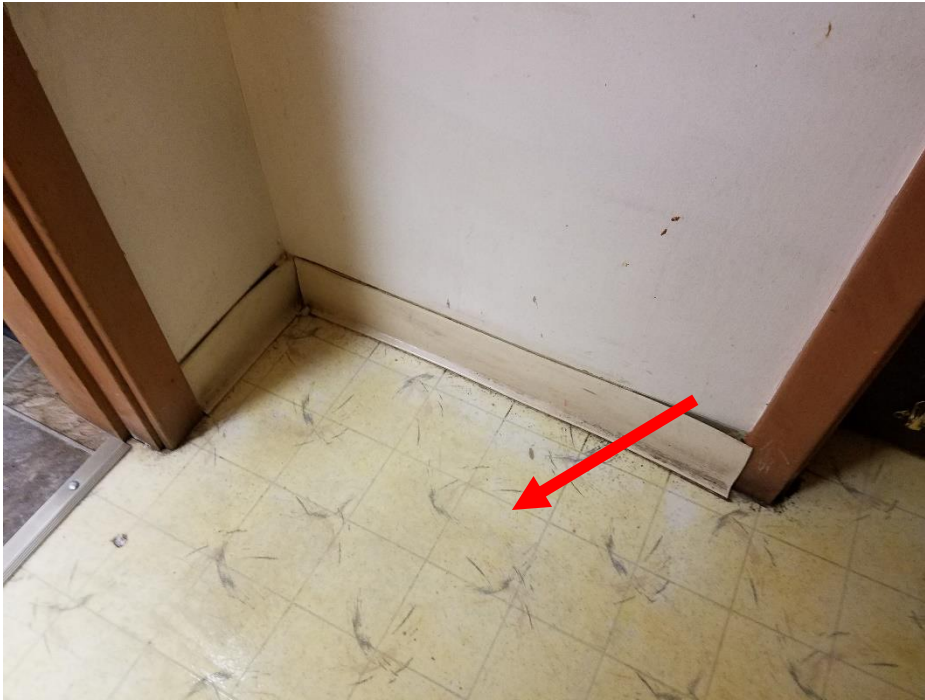
HSA No. 14. 4"x4" Patterned yellow vinyl floor sheet w/ yellow mastic

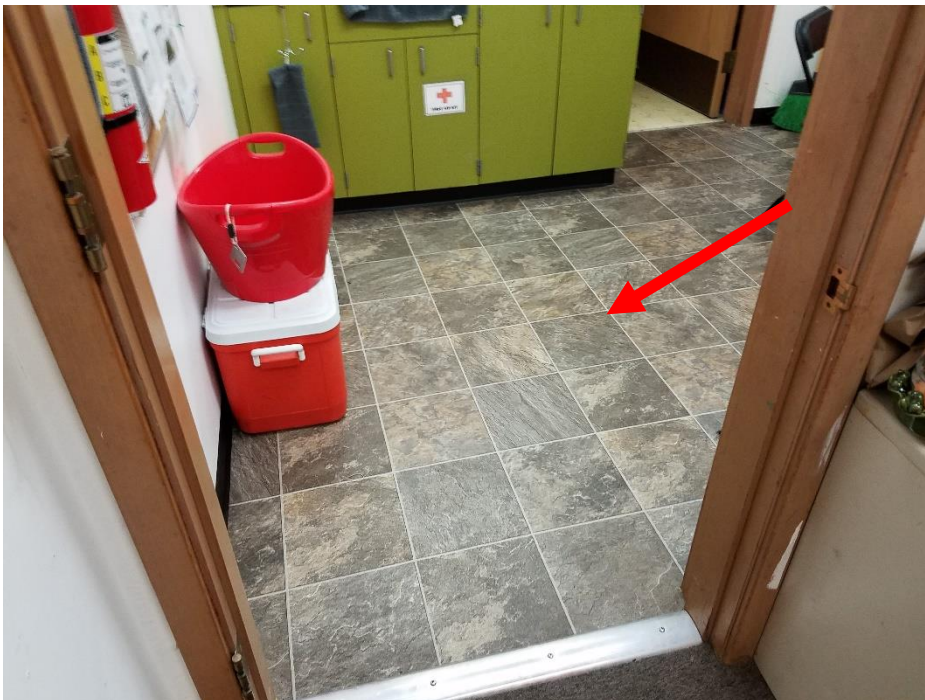
BCC-15-01	12"x12" Marble patterned brown vinyl floor sheet w/ brown mastic	Lunch room in the northwest offices in the northern building.	Tile: ND Mastic: 4% Chrysotile	Non-Friable	Good	900 SF
BCC-16-01	9"x9" red vinyl floor tile w/ black mastic	Southern end of hallway in northern building.	Tile: 10% Chrysotile Mastic: 5% Chrysotile	Non-Friable	Good	60 SF

HSA No. 15. 12"x12" Marble patterned brown vinyl floor sheet w/ brown mastic

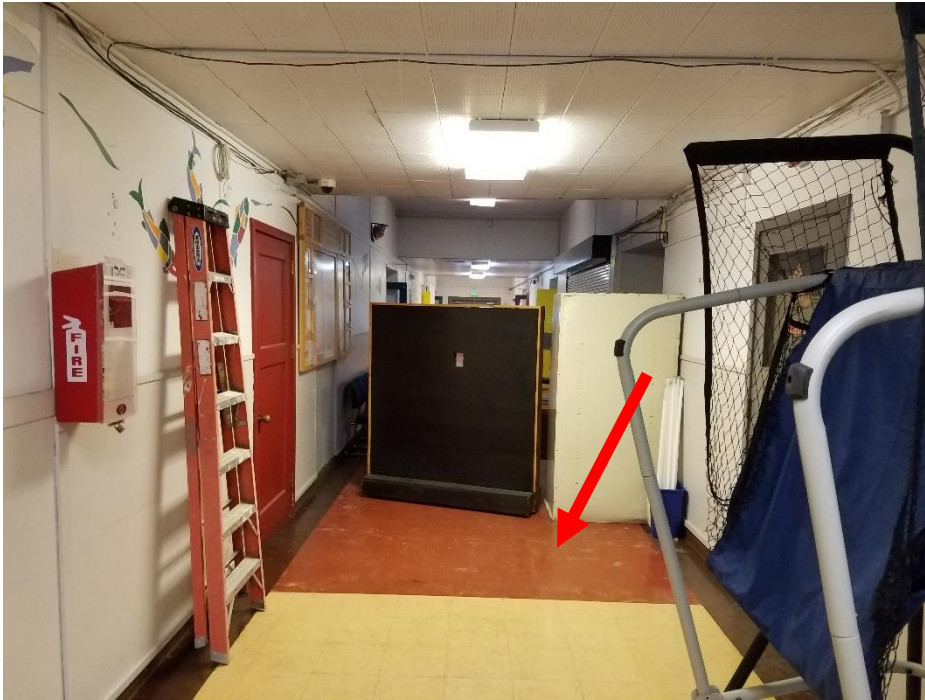
HSA No. 16. 9"x9" Red vinyl floor tile w/ black mastic

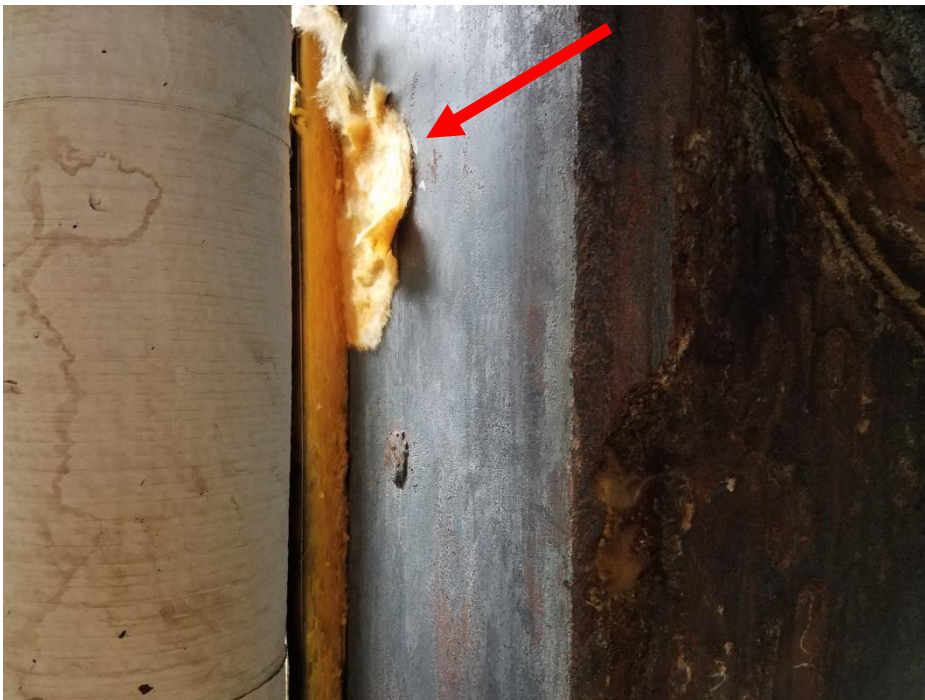
HSA No. 17. Yellow fiberglass insulation with fiber backing and black mastic

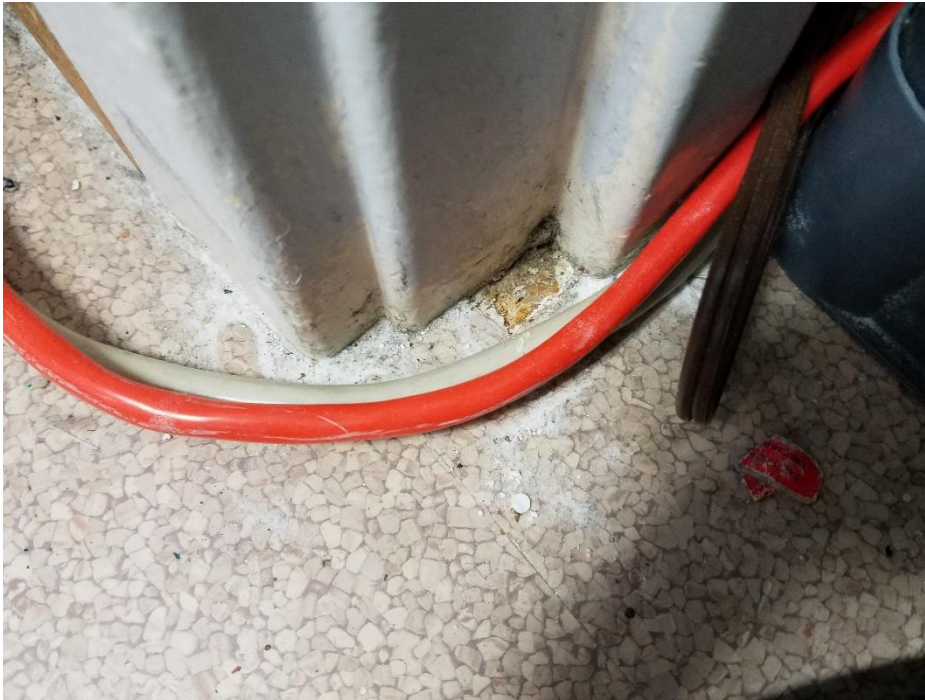
HSA No. 18. Grey vinyl floor sheet w/ light specks and yellow mastic

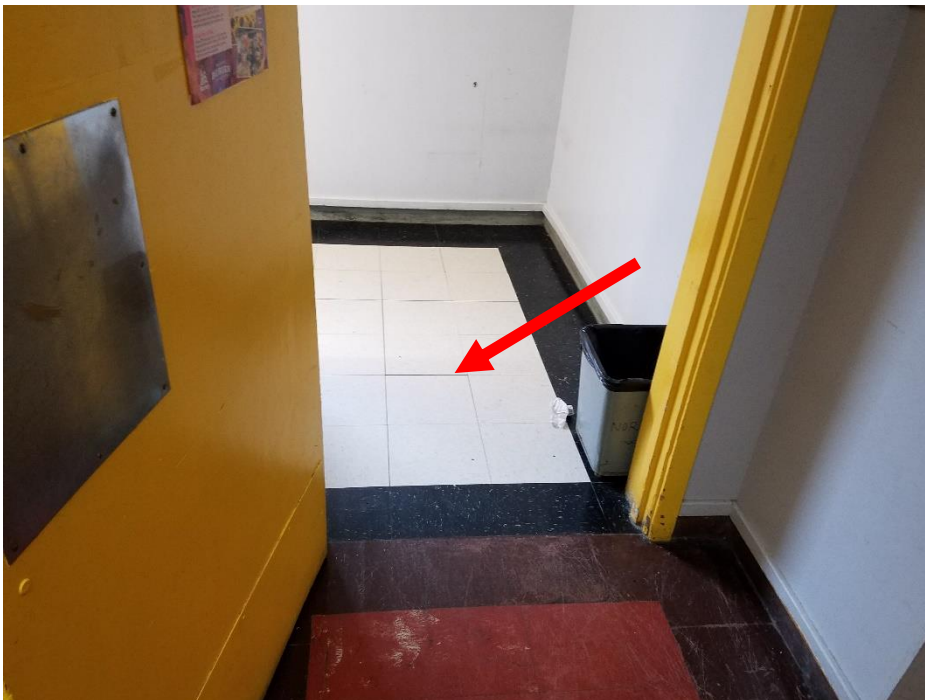
HSA No. 19. 12"x12" White vinyl floor tile w/ black mastic

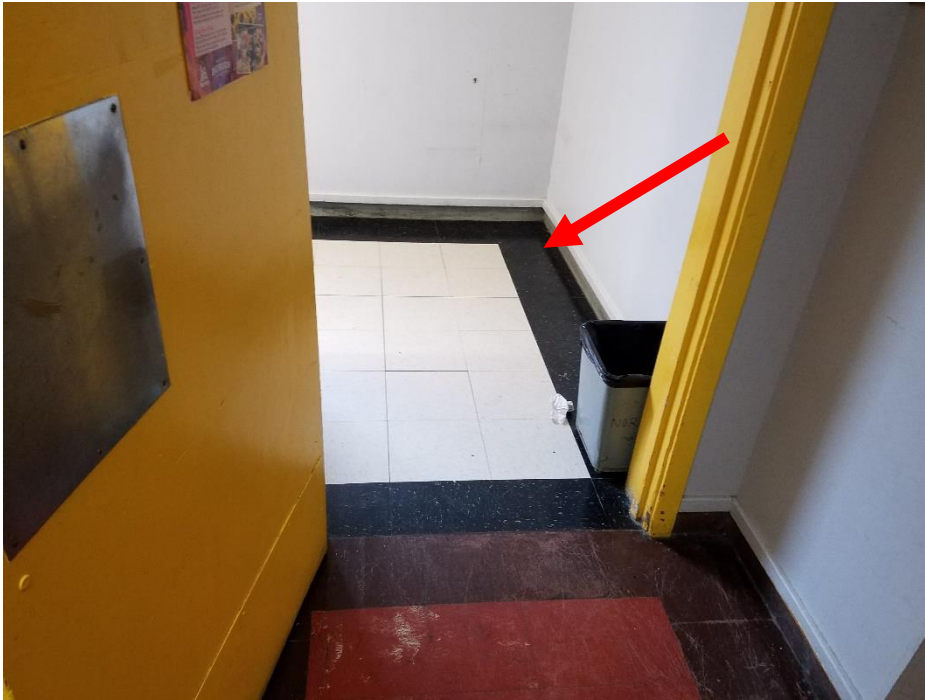
HSA No. 20. 12"x12" Black vinyl floor tile w/ black mastic

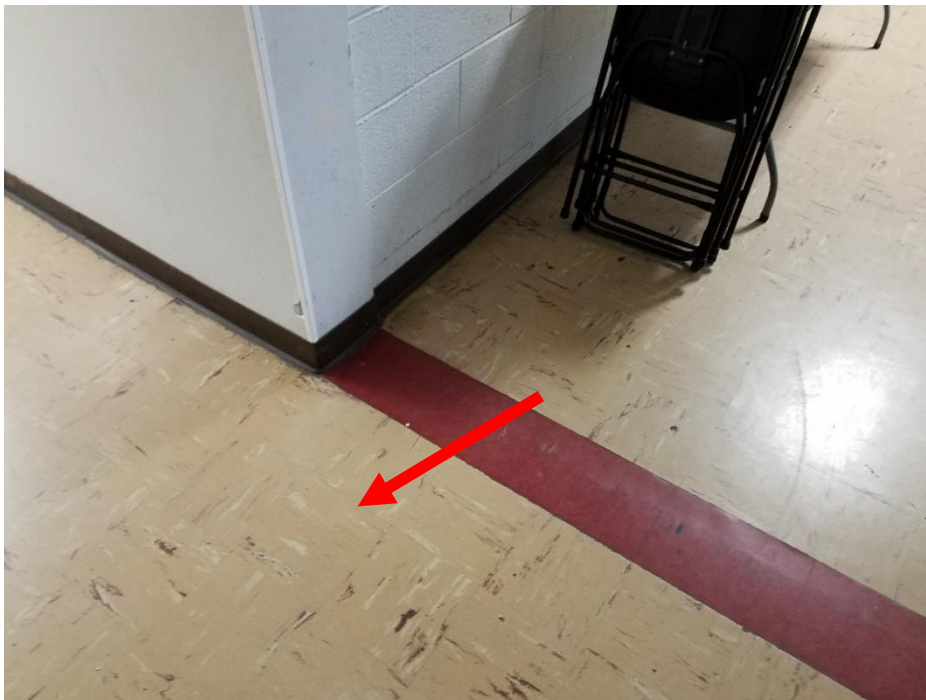
HSA No. 21. 9"x9" Tan vinyl floor tile w/ red streaks

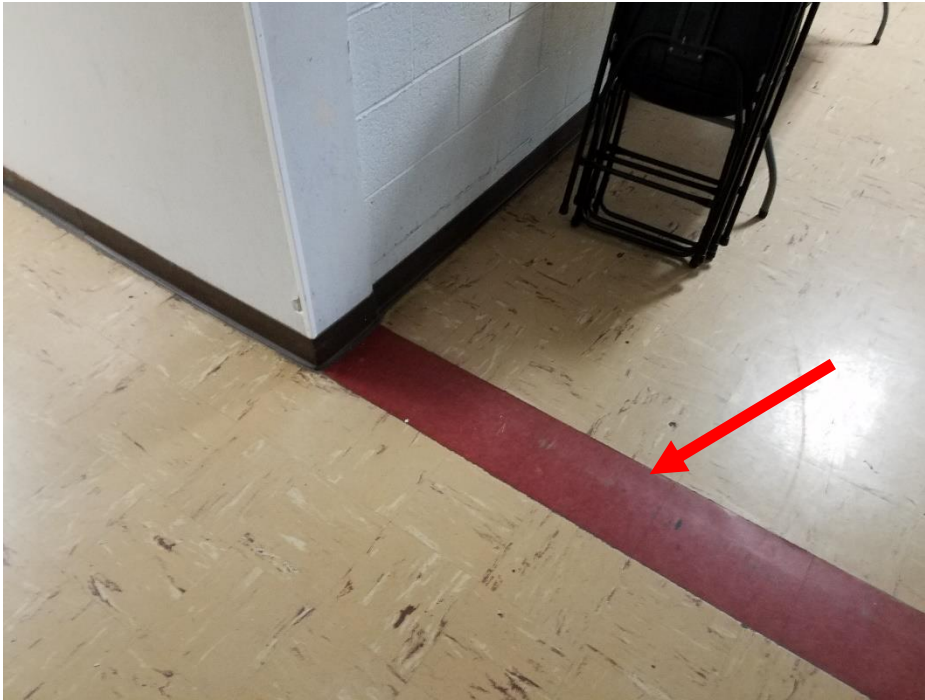
HSA No. 22. 12"x9" Red vinyl floor tile w/ compact grey material

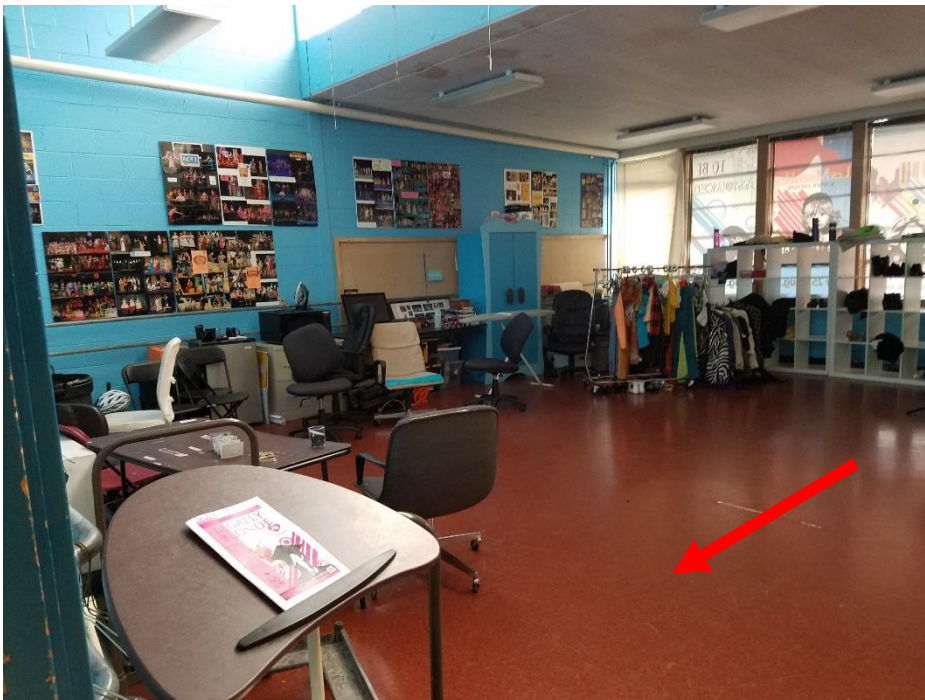
HSA No. 23. Red vinyl floor sheet w/ mastic

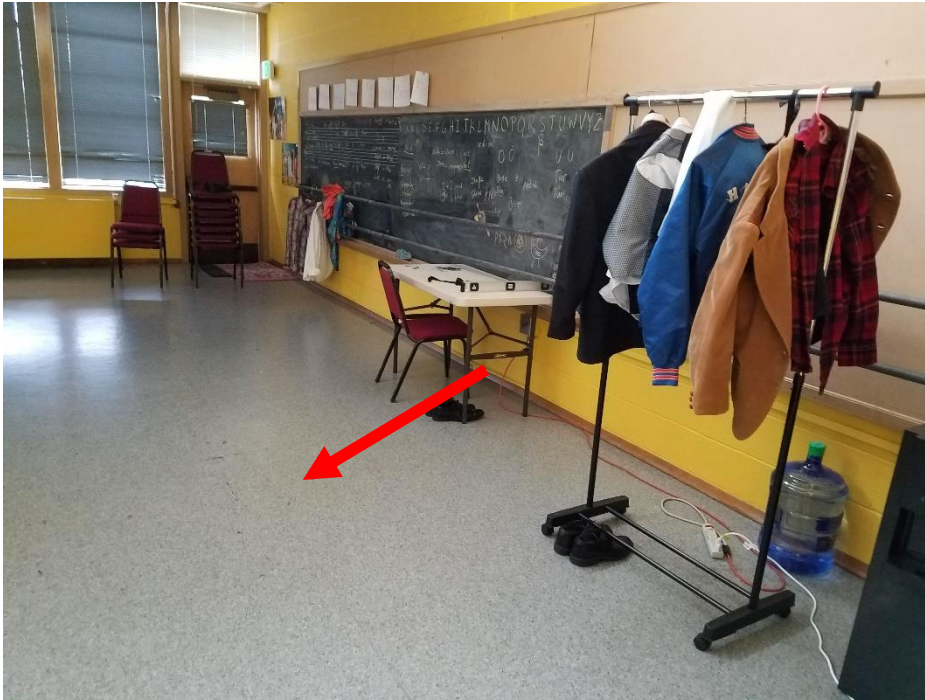
HSA No. 24. Grey layered vinyl floor sheet w/ mastic

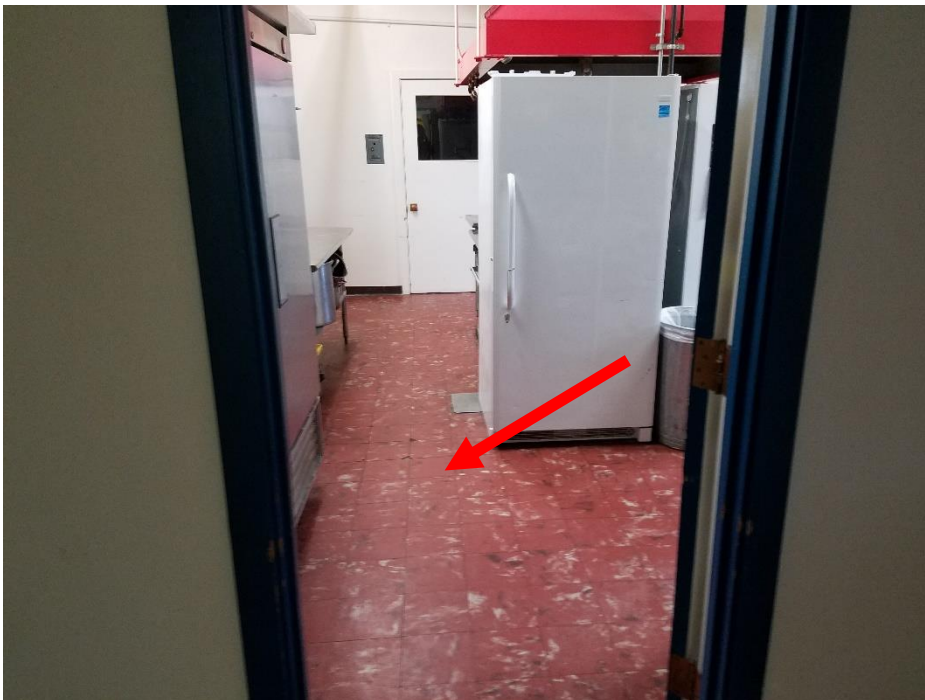
HSA No. 25. 9"x9" red vinyl floor tile w/ black mastic

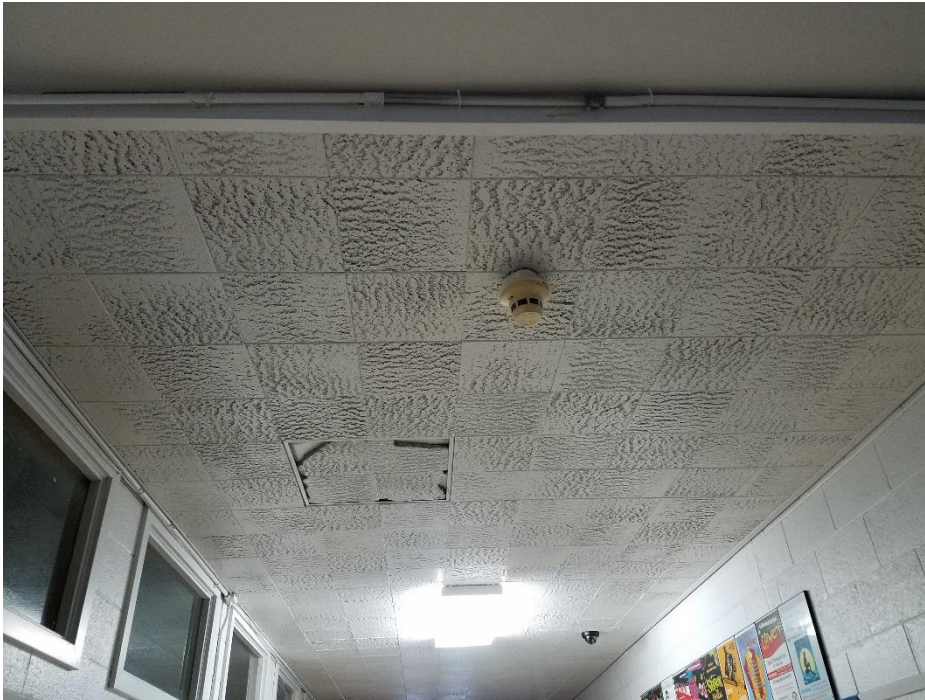
HSA No. 27. 12"x12" Patterned white ceiling tile w/ brown mastic

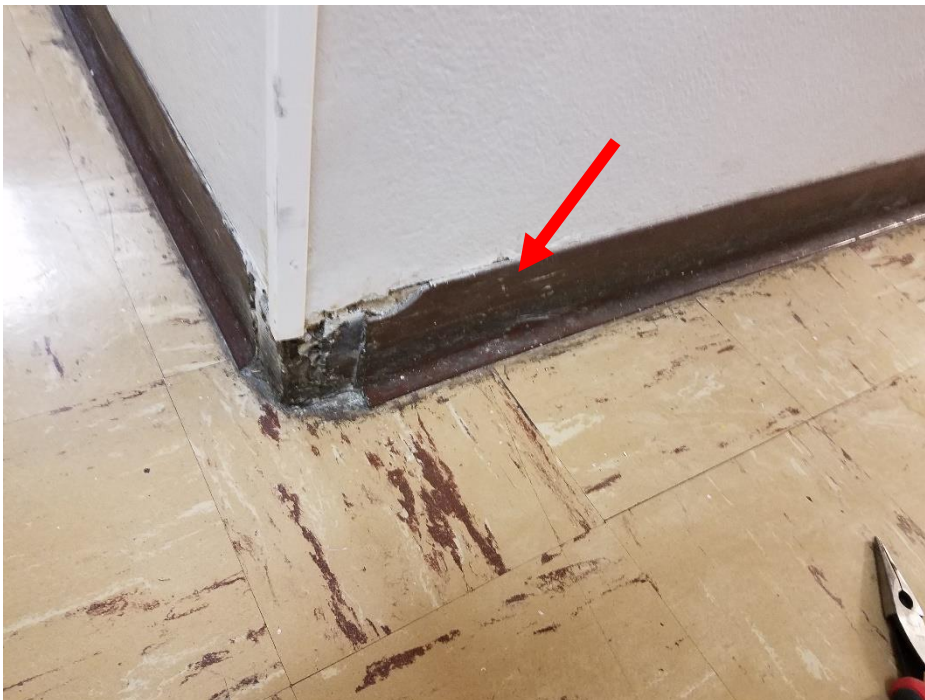
HSA No. 28. 4" Brown vinyl cove base w/ tan mastic

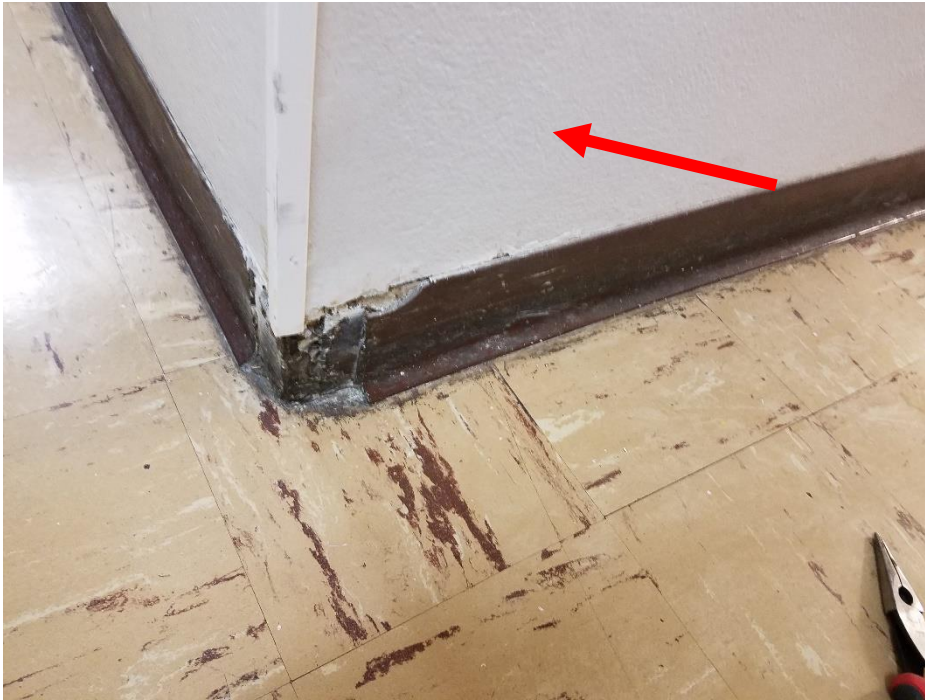
HSA No. 29. Plaster

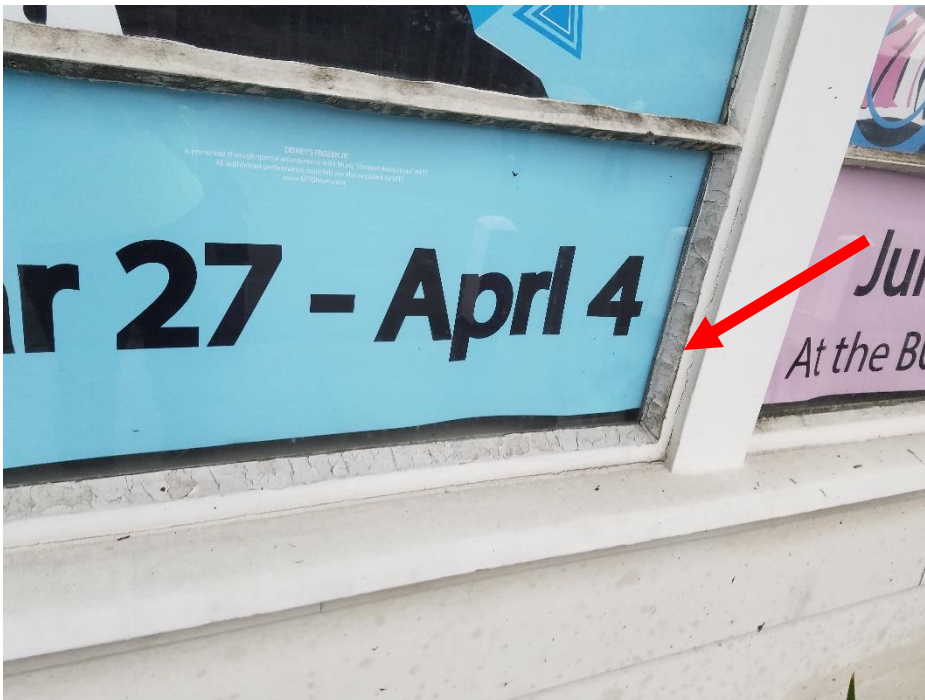
HSA No. 30. White glazing compound
